The Thornton Beach State Park deep rotational landslide Daly City, California

Martin D. Liebhardt
San Jose State University

**THE THORNTON BEACH STATE PARK
DEEP ROTATIONAL LANDSLIDE
DALY CITY, CALIFORNIA**

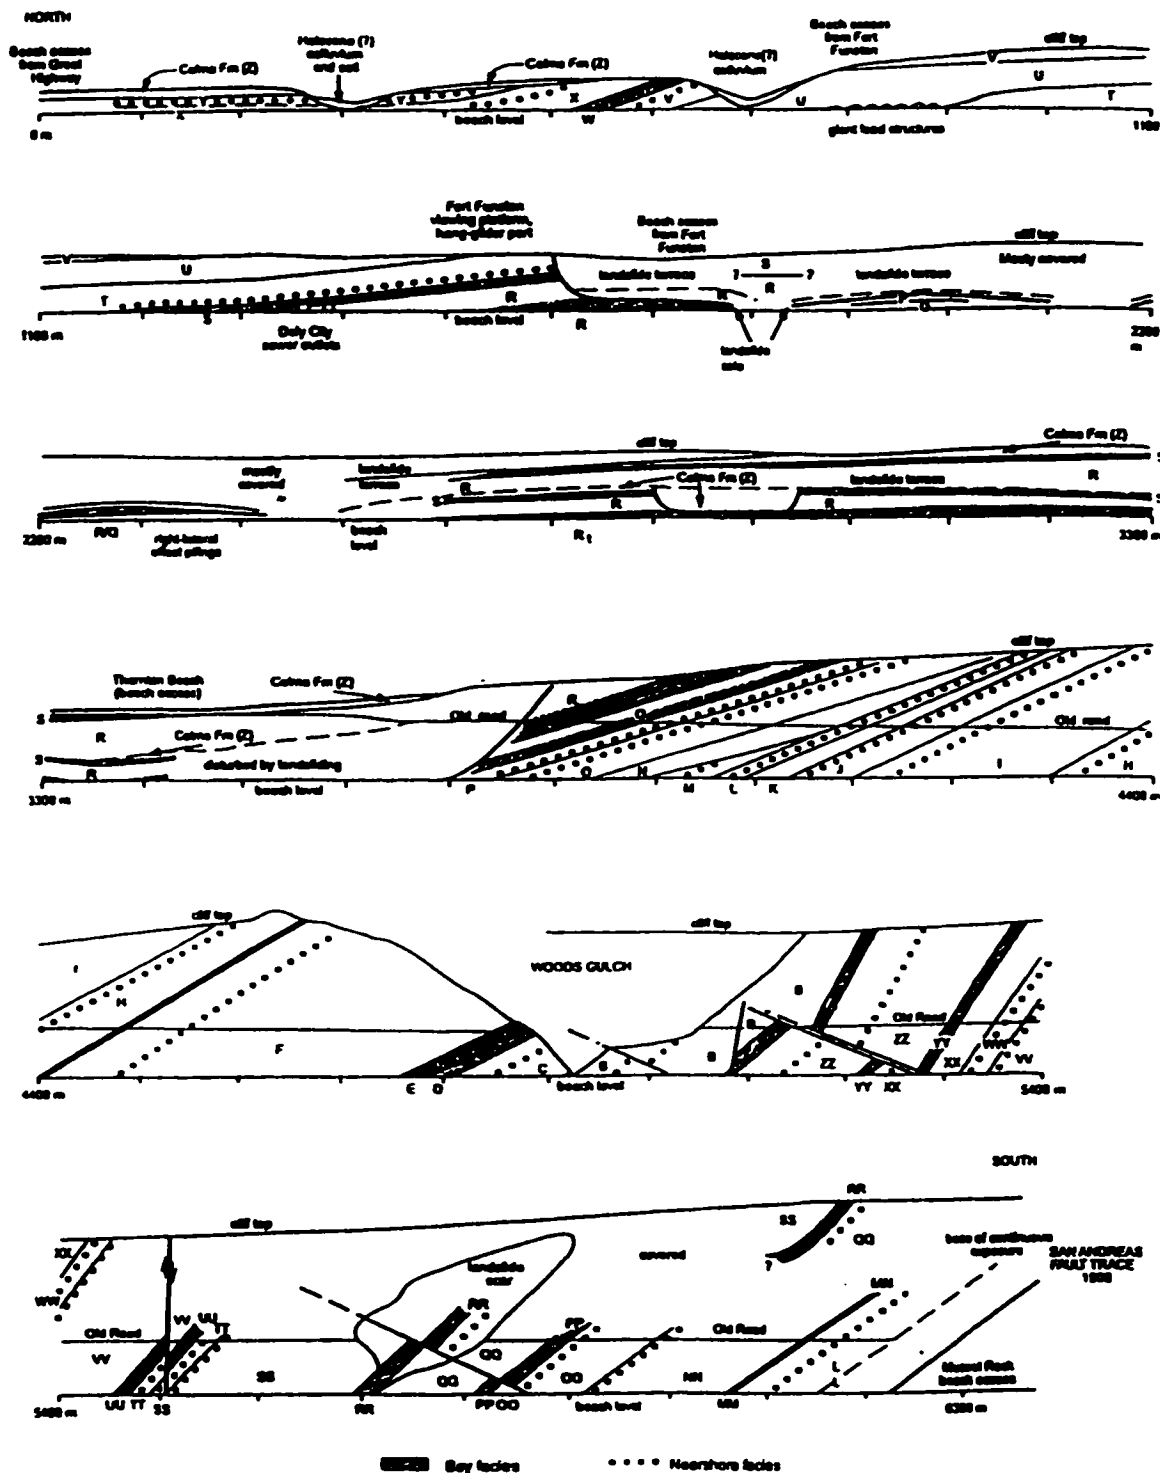
Figure 9. Generalized cross section of Merced and Colma Formations from Mussel Rock to the Fort Funston National Park. Note repeated stratigraphic units (R and S) in the Thornton Beach area. Scale is meters (Clifton and Hunter, 1999).

Figure 9 shows how the stratigraphic units recorded landslide movement. In the area of Thornton Beach State Park, sequences Z (Colma Formation) and S, as well as Unit R₄₋₂, are shown in place along the west facing slope. Below this, along a landslide terrace, the units are also shown in the same sequence located in the head scarp. Correlating the displaced stratigraphic units shows the units have been displaced by as much as 30 meters. Field work conducted verified the displacement of these units.

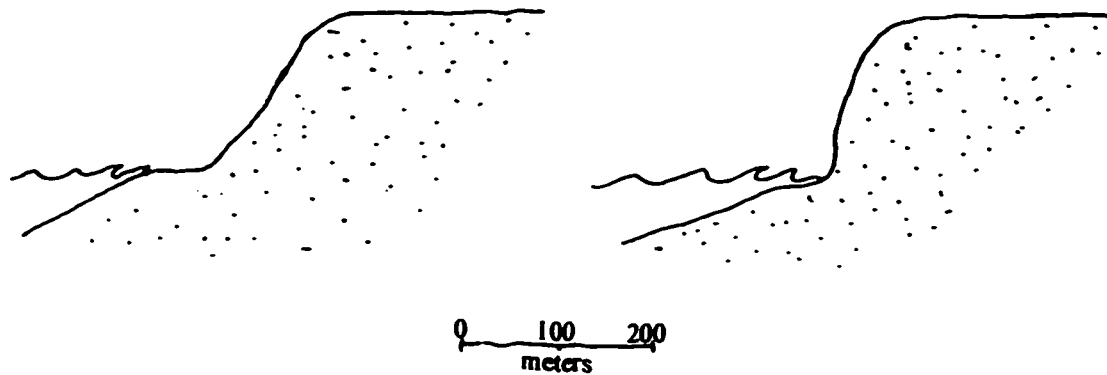
Figures 18 A - F are a series of sketches of the Thornton Beach area illustrating the hypothesis that an imbricate slip plane system developed due to wave erosion and progressive slope failures. The first sketch (Fig. 18-A) represents how the Thornton Beach area may have looked prior to the landslide. The relatively steep slopes, close to the angle of repose of the slope forming materials (approximately 32°), were undermined and eroded by constant wave action shown in Figure 18-B, eventually leading to the landslide (Figure 18-C). Figure 18-D shows the wave action continuing to erode the shoreline and transporting the landslide debris down the coastline by longshore currents. Because of the continual wave action, the landslide never stabilizes, and continues to slip. As the landslide debris and the shoreline are eroded, the area farther inland becomes less

Figures 18 A - B. Sketches of the Thornton Beach area showing cycle of wave erosion and undercutting.

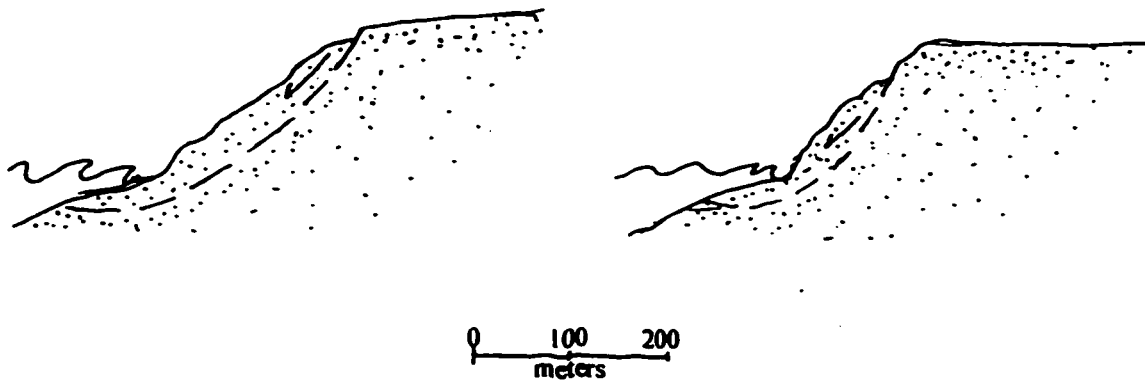
Figures 18 C - D. Sketches of the Thornton Beach area showing the initiation of the landslide and the erosion of the landslide debris.

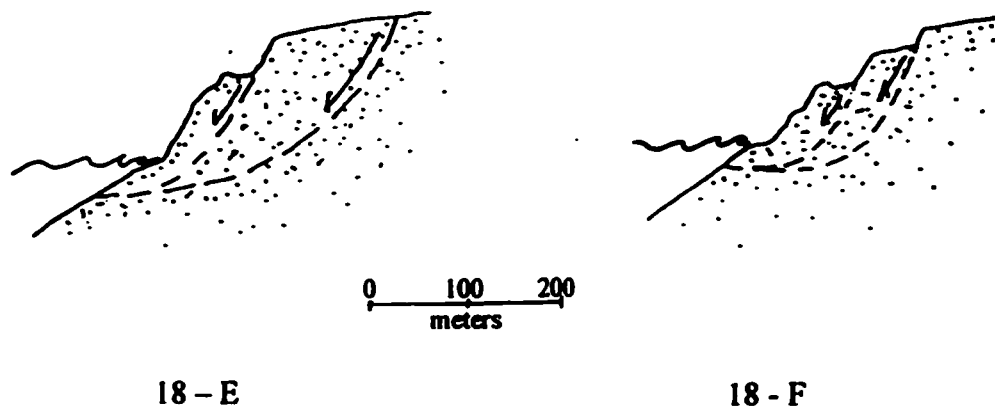
stable, leading to another landslide (Fig. 18-E). The second landslide slip plane joins the original landslide slip plane because the soil is at residual strength instead of peak strength, creating an imbricate system of landslides (Fig. 18-F). This cycle of erosion and failure led to the series of landslides in the Thornton Beach area.

Figures 18 E – F. Sketches of the Thornton Beach landslide showing cycle of wave erosion, undercutting and failure that lead to the imbricate system landslides.

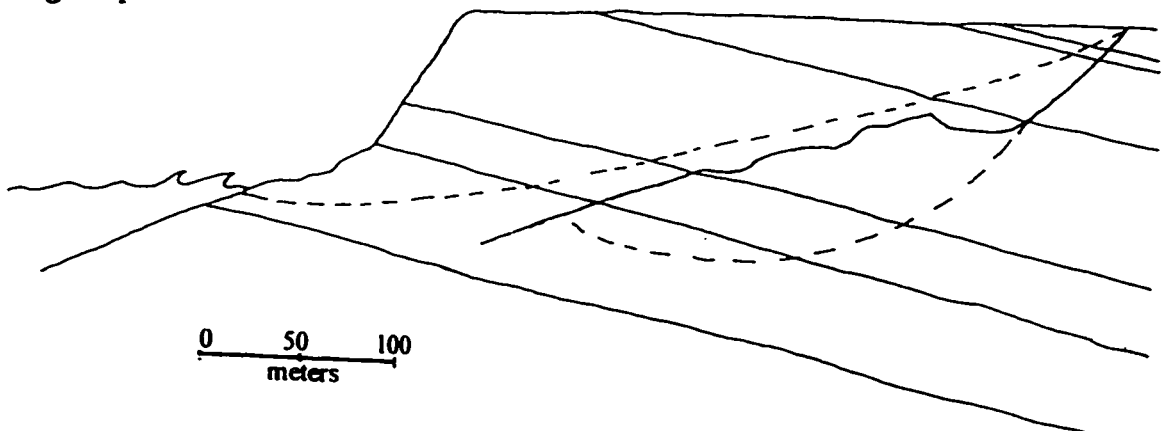
STABL5M was run after restoring 150 meters of displaced material to the slope, thus creating a model of the area as it appeared 500 years ago. Using the current Thornton Beach slip plane as the initiation point, the Factor of Safety of the area 500 years ago was approximately 1.26, stable compared to Factor of Safety values of the

current landslide. The slip plane is shown in Figure 27 as dashed lines at the same initiation point as the current Thornton Beach Landslide.

Figure 27. Sketch of Thornton Beach Landslide with 150 meters (500 feet) of restored units to represent 500 years ago.

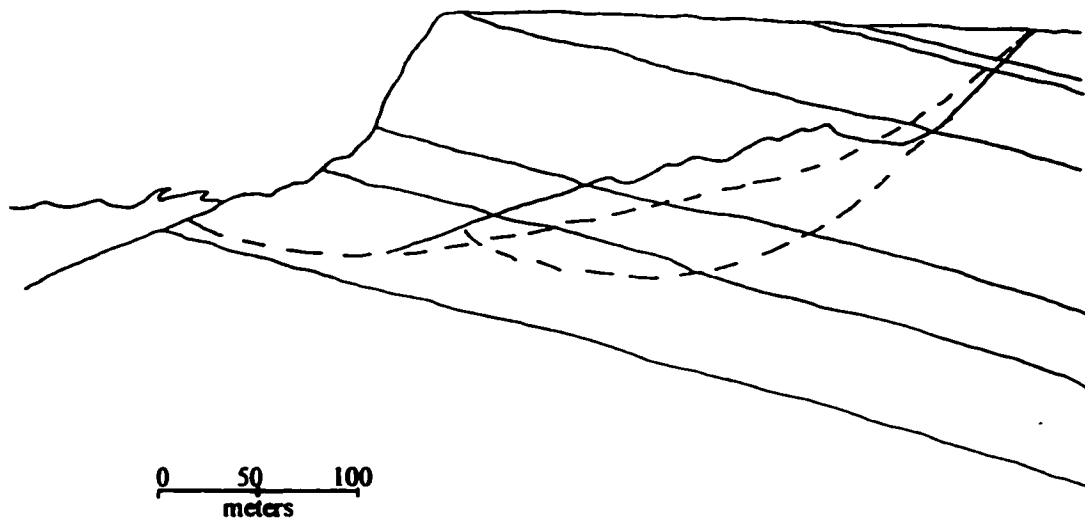
Figure 28 shows a scenario representing the erosion of the land from along the shoreline, increasing the risk of landslide. This was created by removing 30 meters along the 500 year old coast line, representing its state 400 years ago. The dashed lines in Figure 28 represent the current Thornton Beach Landslide location.

Figure 28. Sketch of Thornton Beach Landslide with 120 meters (400 feet) of restored units to represent 400 years ago.

The slip plane shown in Figure 28 has a Factor of Safety of 1.03, close to being unstable. Therefore, based on the modeling conducted, the Thornton Beach Landslide was initiated approximately 400 years in the past. The results of the computer modeling are shown in Appendix F. Because of the variability of the rainy winter season, the wave erosion rate, and the true nature of the area's topography during the actual time of the slippage, this model is only an approximation of the timing of the area's actual instability. However, this approximation can be useful in determining how instability has affected the current shoreline, and may be useful for predicting how slope stability will eventually affect the area.

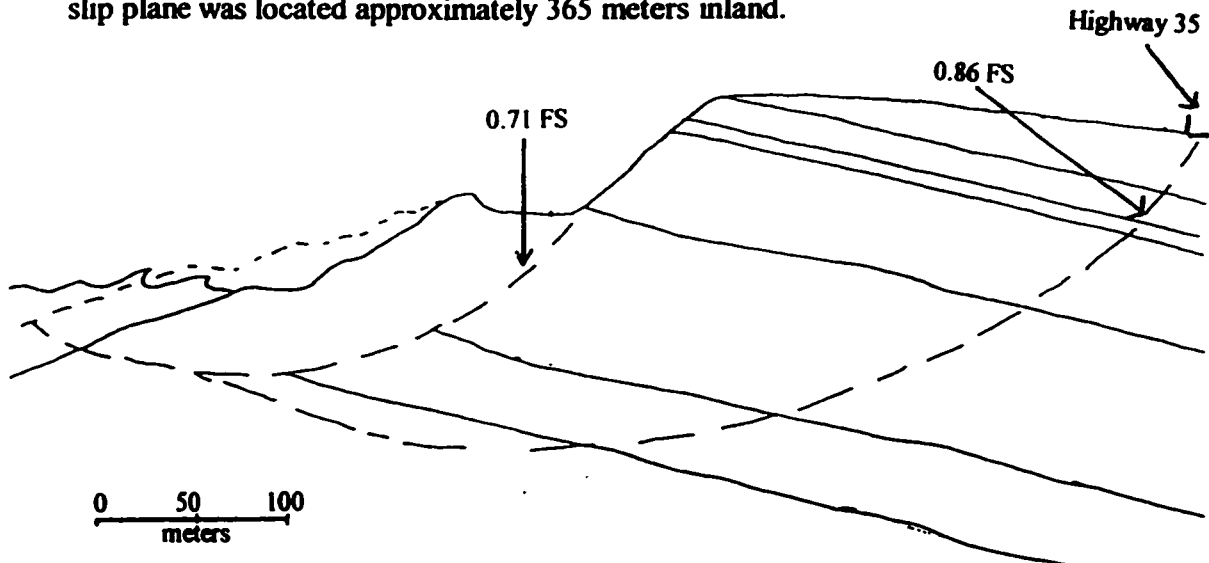
To predict the stability of the area 20 years into the future, a model was created using the same assumption of a 0.3 meters per year erosion rate. Figure 29 is a sketch of the Thornton Beach Landslide according to this model, with 6 meters removed from the current shoreline. The dashed areas show the current Thornton Beach Landslide and the slip planes associated with the lowest Factor of Safety. This model produced a Factor of Safety of 0.71 to 0.86, indicating the area would be very unstable over the next two decades. The lowest Factor of Safety (0.71) slip plane was located in the general area of the current slip plane on the Olympic Golf Course, and the highest factor of safety (0.86) slip plane was located approximately 365 meters inland.

Figure 29. Sketch of Thornton Beach Landslide with 6 meters (20 feet) eroded away to represent 20 years into the future.

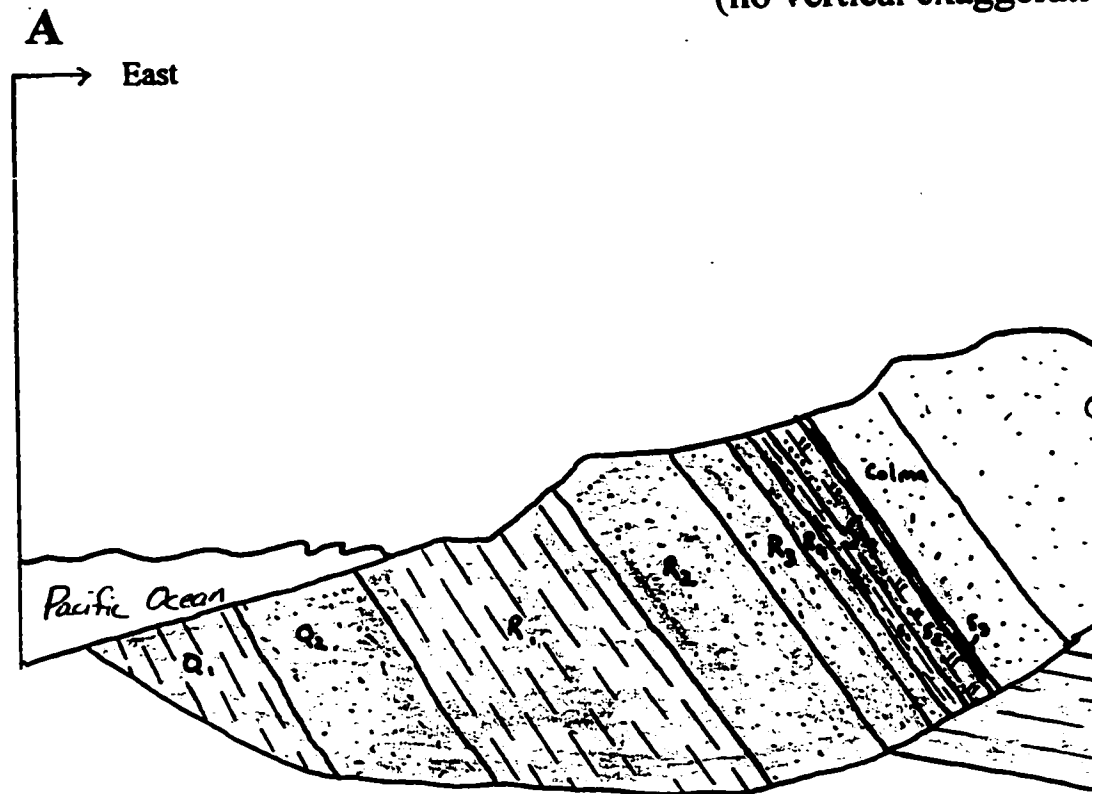
APPENDIX E
Geologic Section of Thornton Beach Landslide

Geologic Section
Of
The Thornton Beach Land
Daly City, California
1 inch = 100 feet
(no vertical exaggeration)

Section shows the Colma Formation and the Merced Formation, (Clifton and Hunter, (

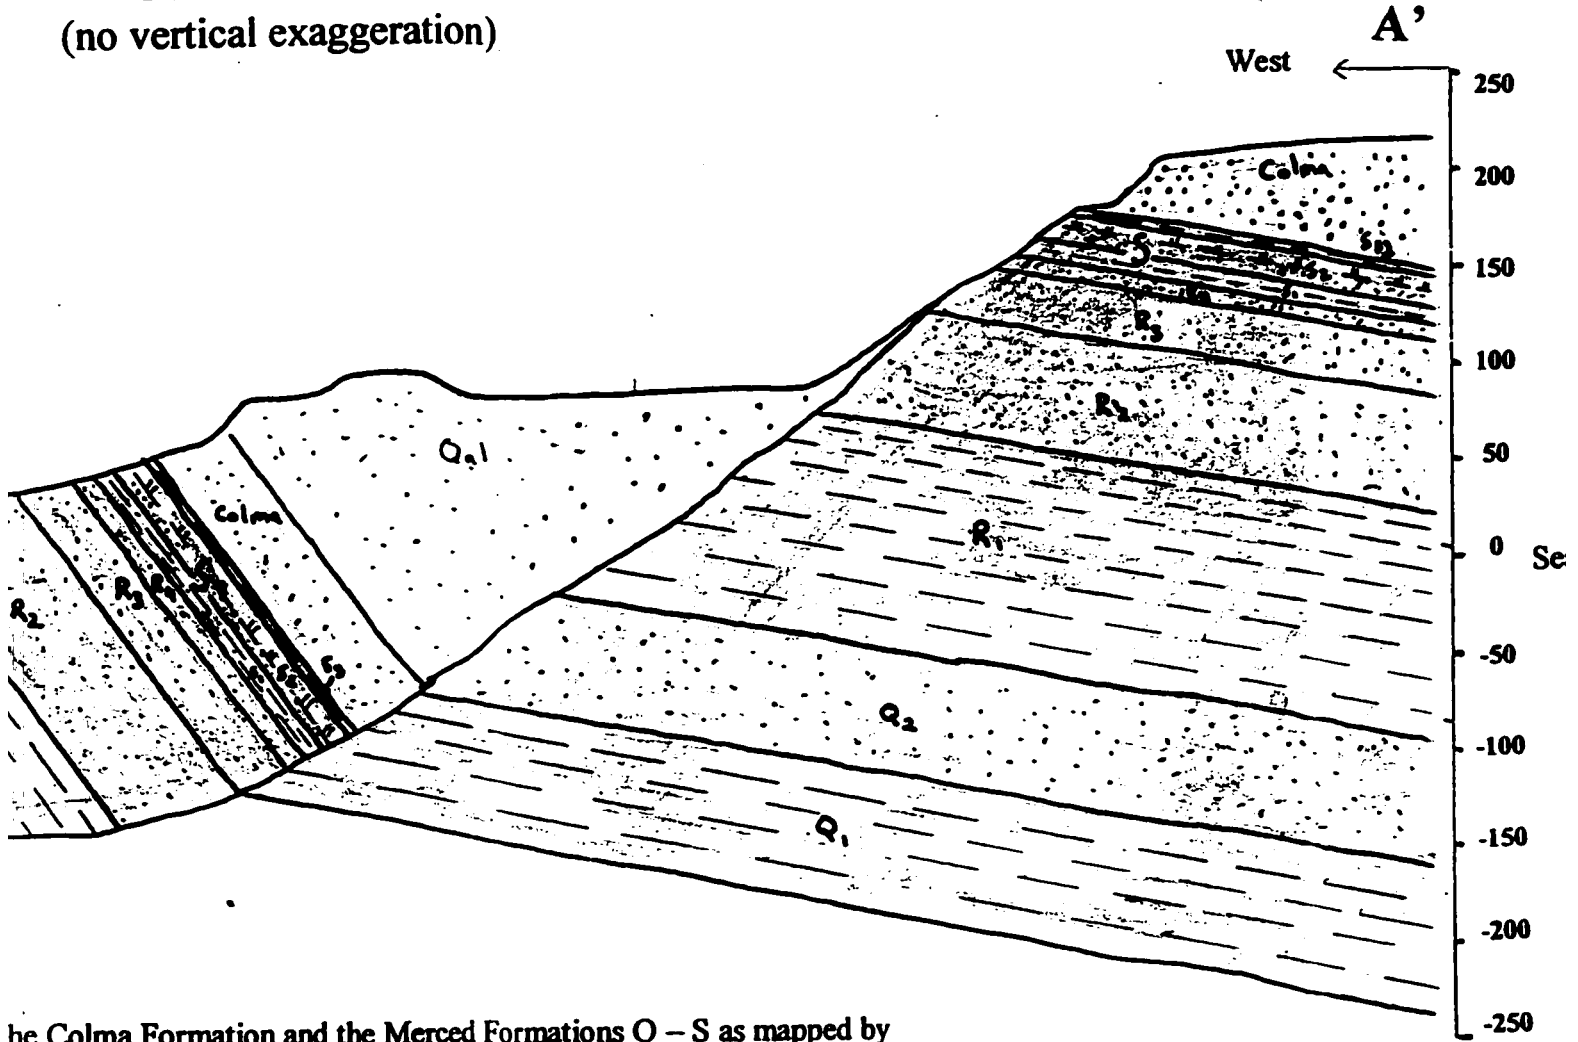
Geologic Section
 Of
 The Thornton Beach Landslide
 Daly City, California
 1 inch = 100 feet
 (no vertical exaggeration)

The Colma Formation and the Merced Formations Q – S as mapped by
 Clifton and Hunter, (1987).

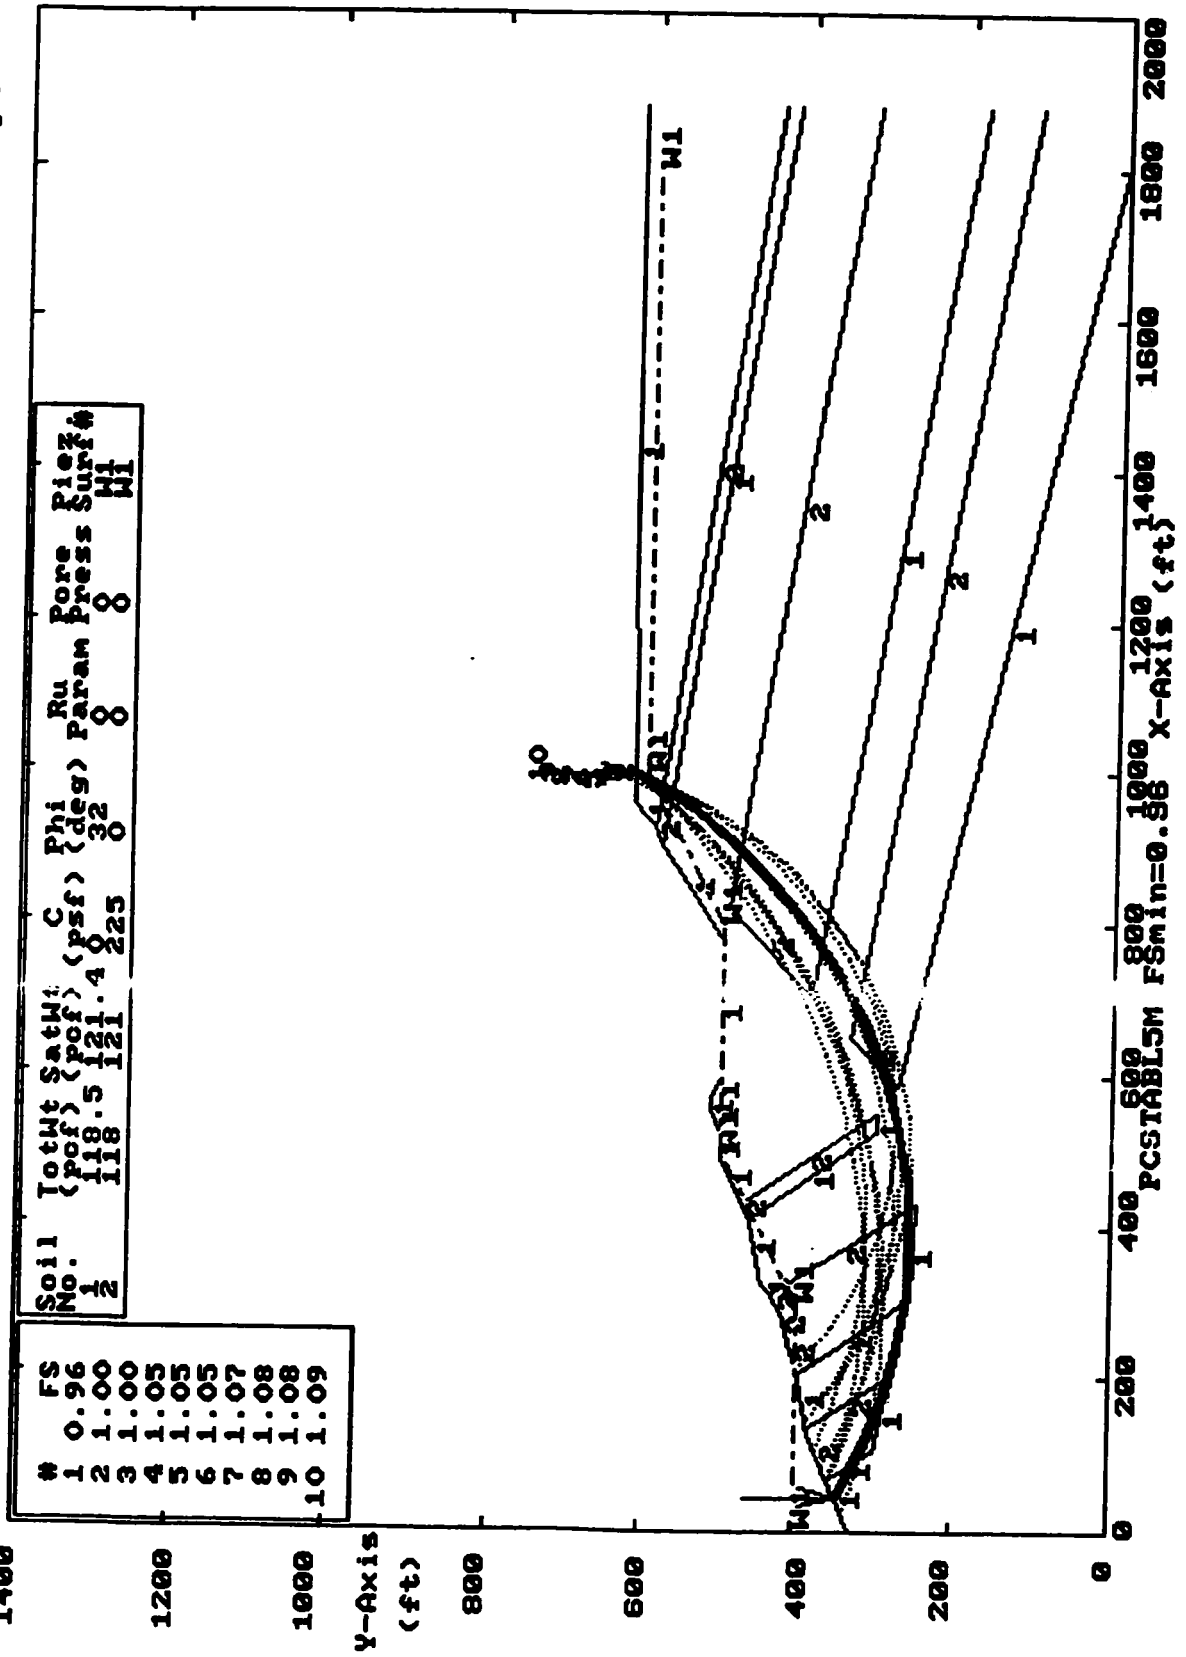
THORION BEACH - NORTH - Current Close to original scarp - h₁ water tbl
Ten Most Critical. A:N_DPRO14.PLI By: Martin Liebhards 08-17-99 1:50pm

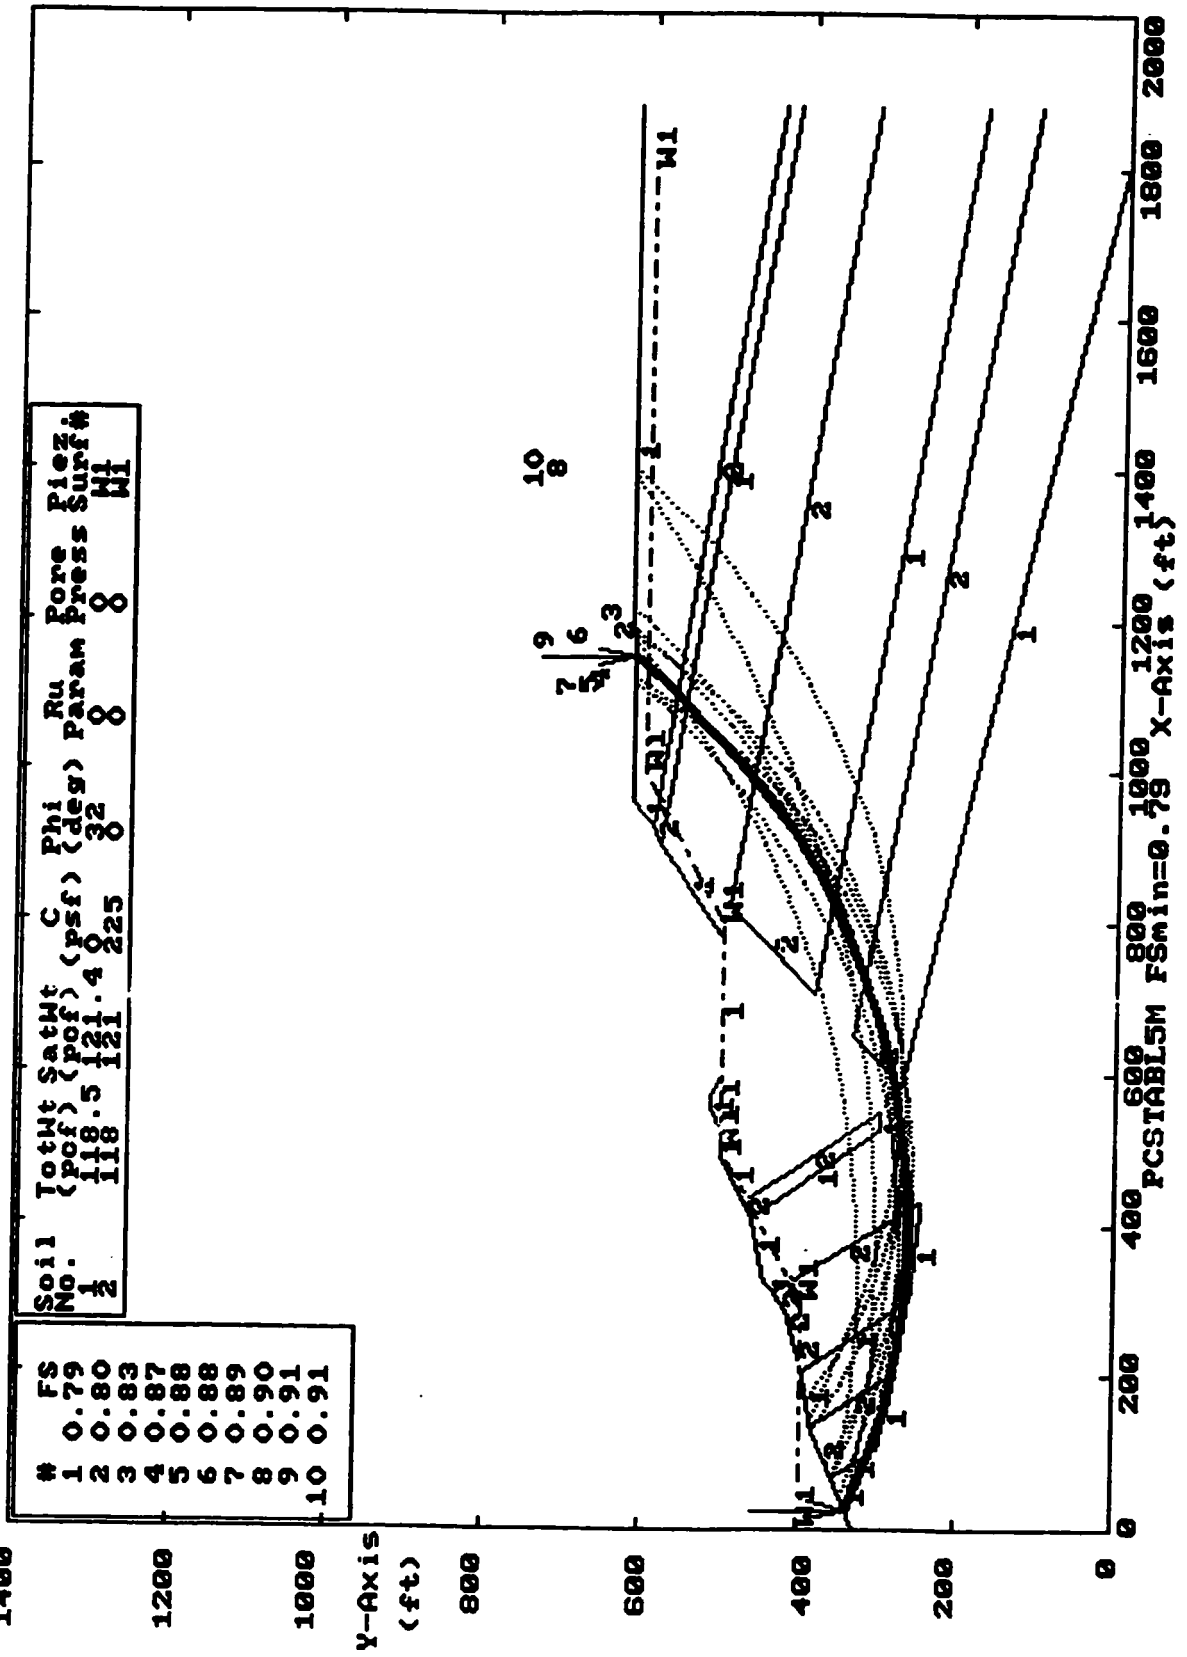
THORNTON BEACH - NORTH - Current Away from original scarp - hi water tbl
Ten Most Critical. A:N_DPROT5.PLT By: Martin Liehardt 09-16-99 3:24pm

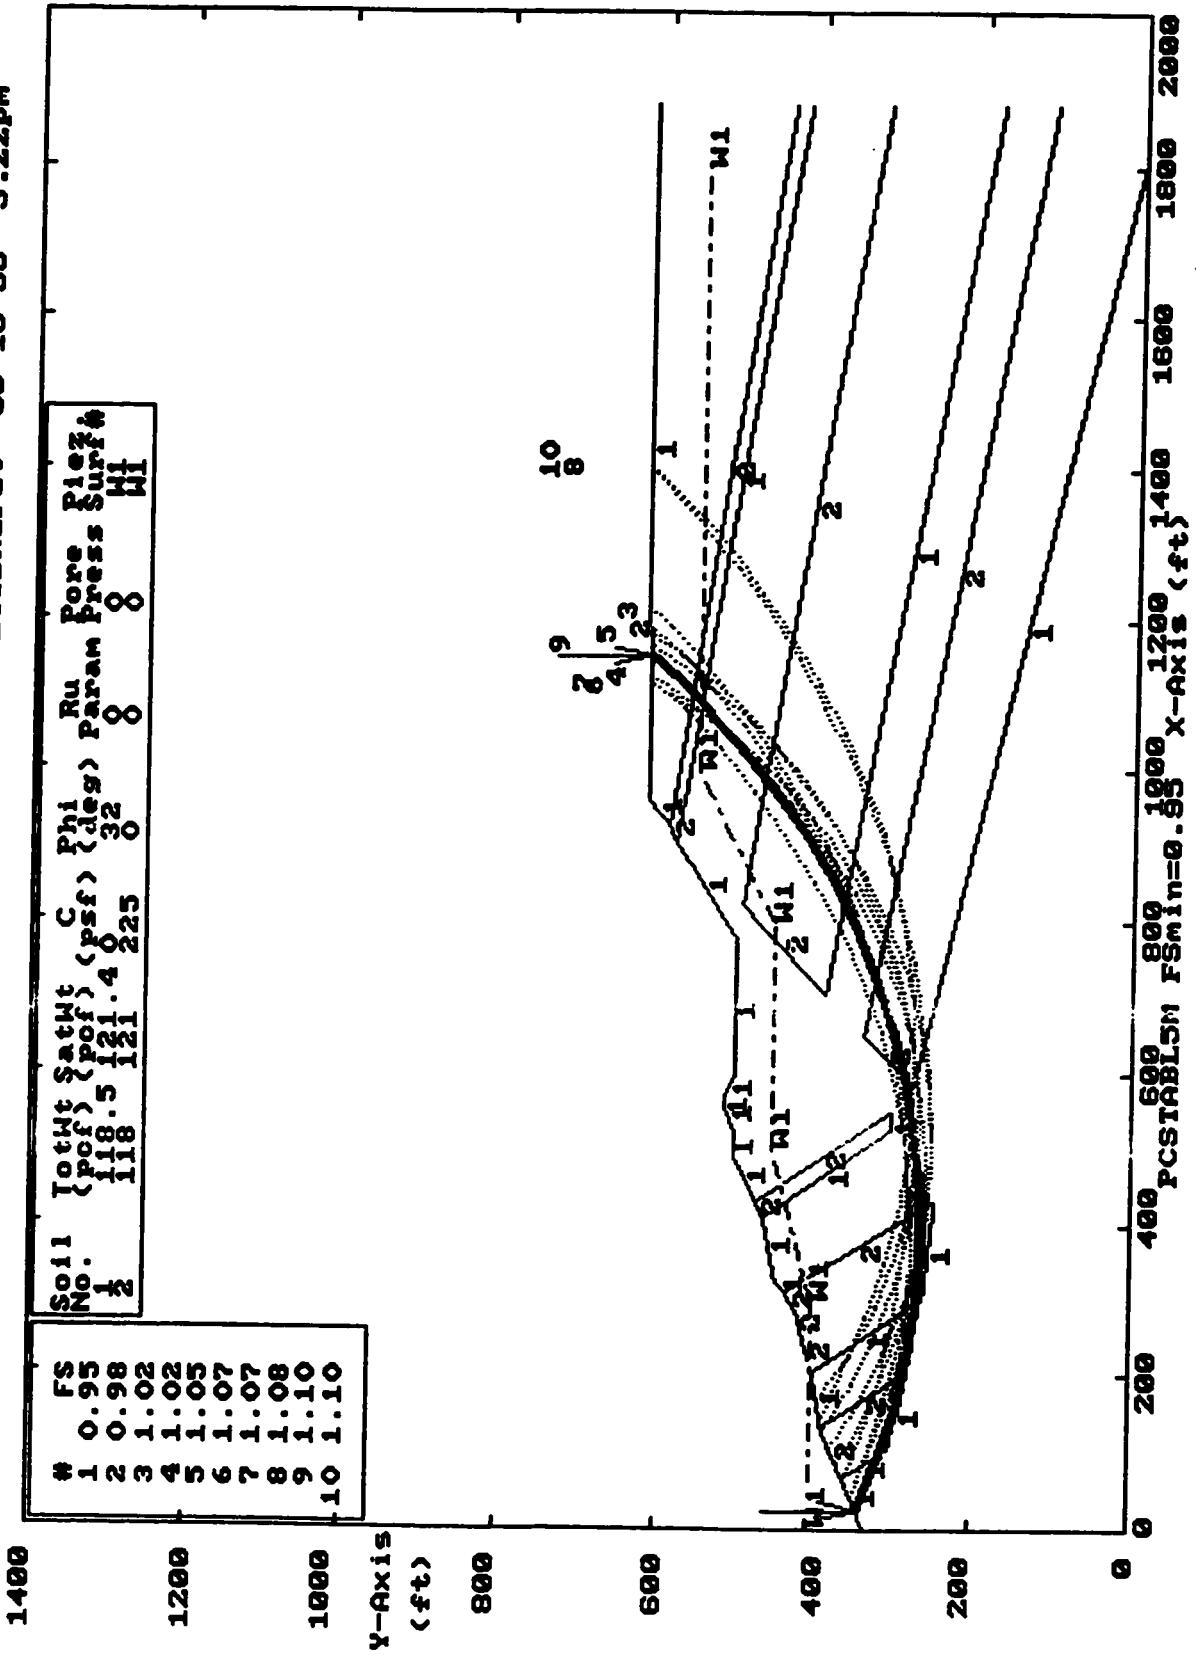
THORNTON BEACH - NORTH - Current Away from original scarp - to water tbl
 Ten Most Critical. A:N_DPROT2.FLT By: Martin Liehardt 89-16-99 3:22pm

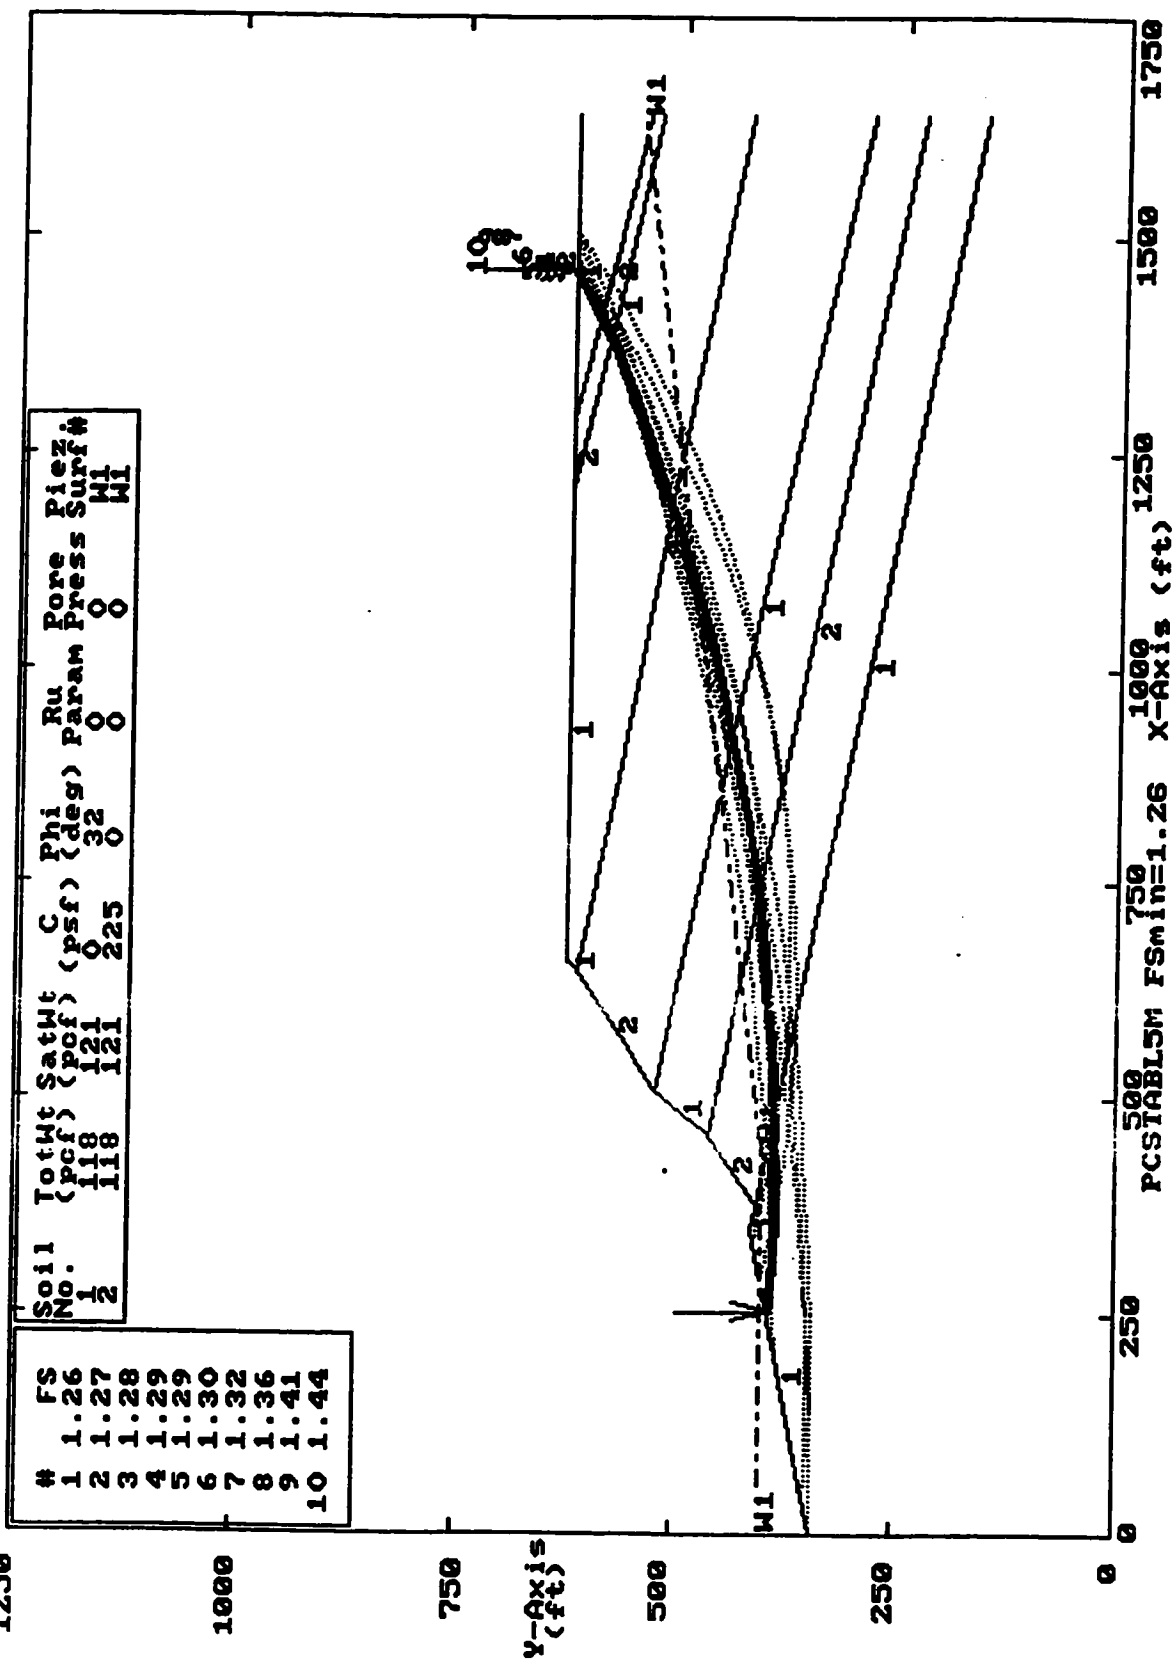
Thorton Beach - in place strat 500 feet from current shore line
 Ten Most Critical. A:N_DP_500.PLI By: Martin Liebhardt 09-16-99 3:25pm

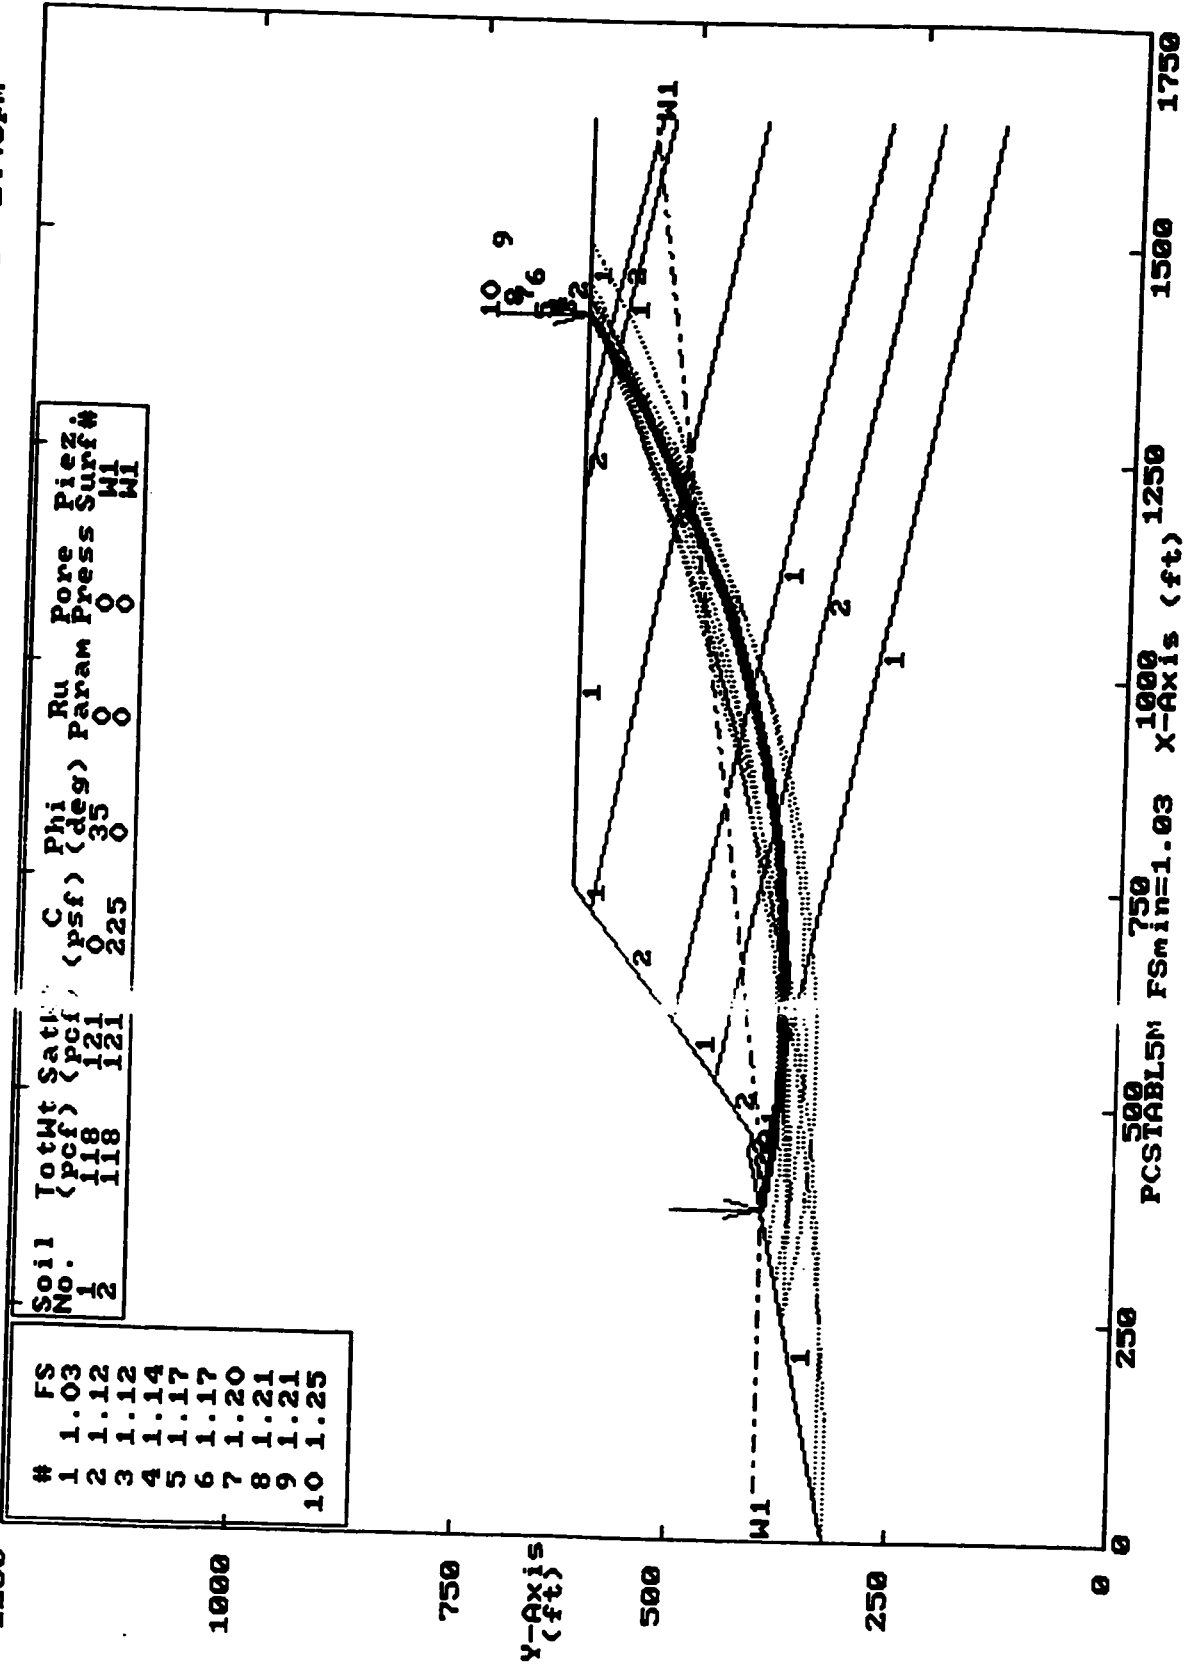
Thorton Beach - in place strat 400 feet from current shore line
 Ten Most Critical. A:N_DP_400.PLT By: Martin Liebhardt 09-28-99 2:46pm

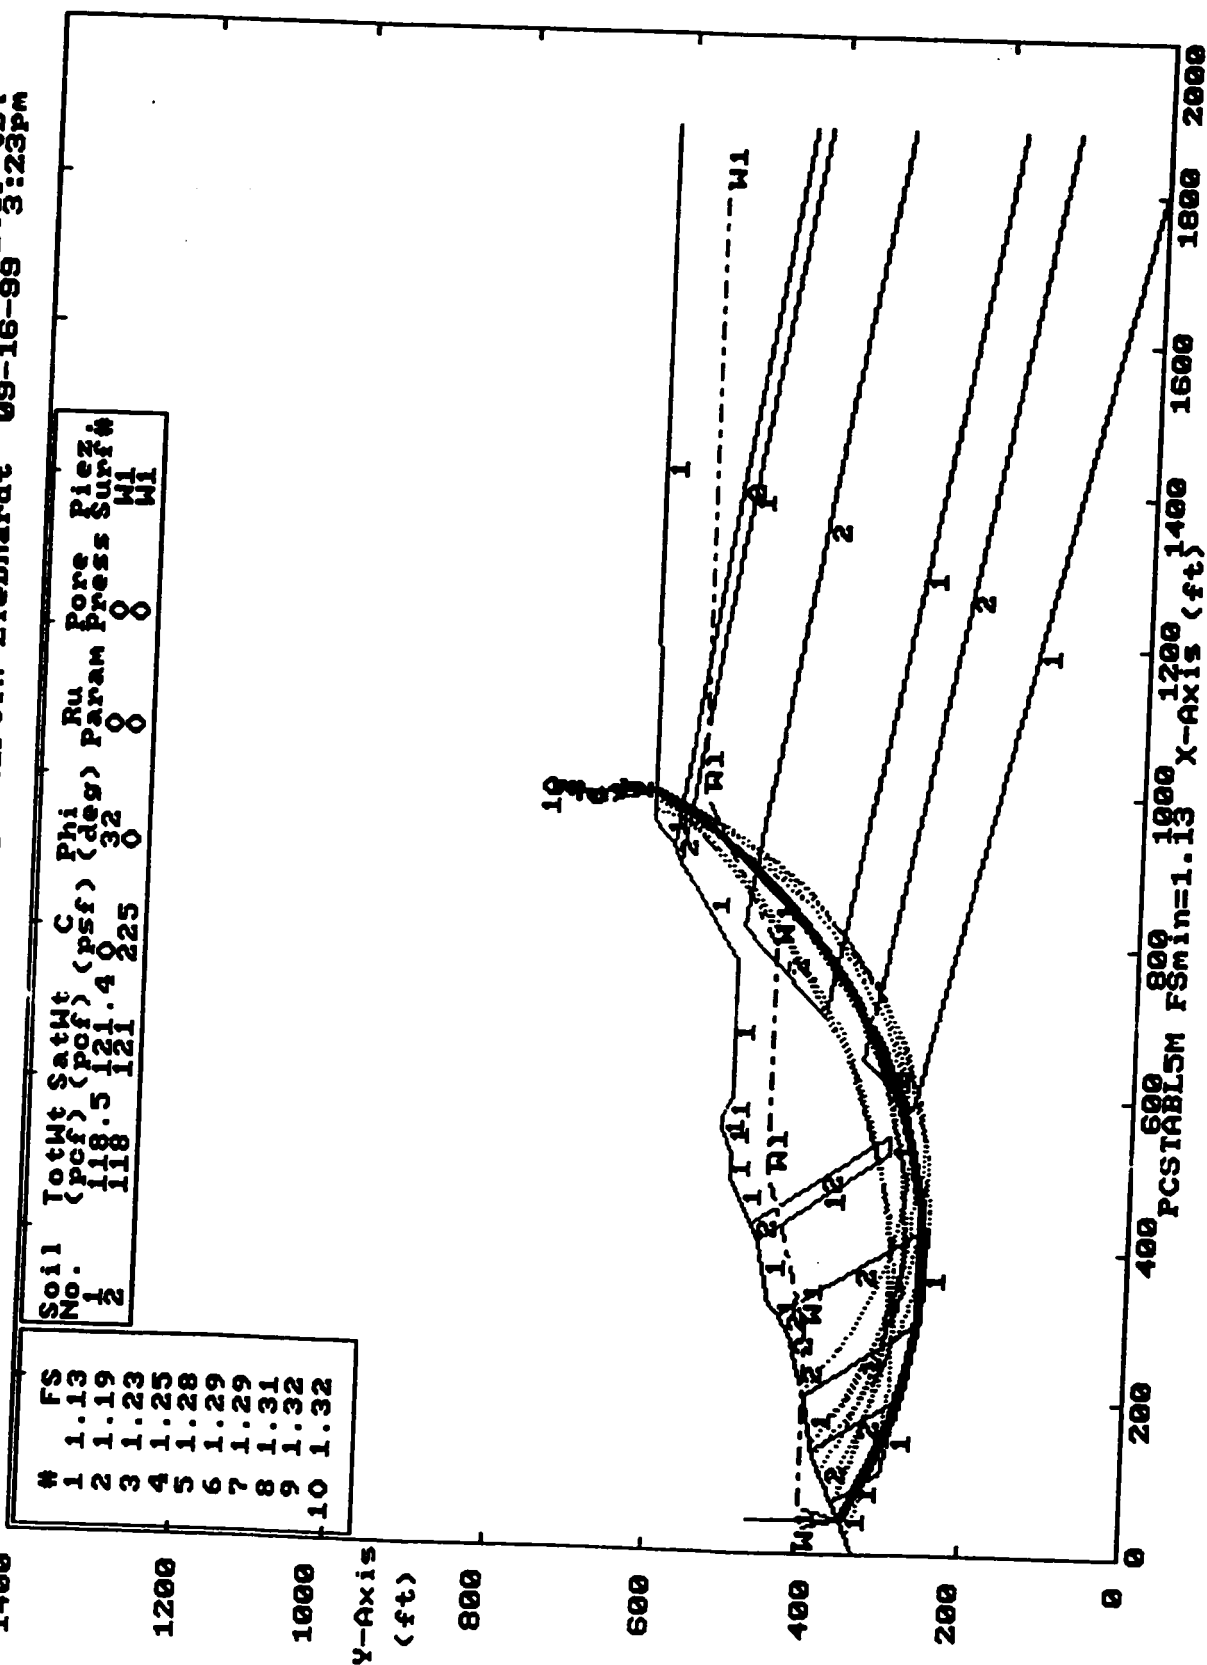
THORION BEACH - NORTH - Current Close to original soarp - low water tbl
 Ten Most Critical. A:N_DPROT3.PLT By: Martin Liebhardt 09-16-99 3:23PM
